New Hampshire Volunteer Lake Assessment Program

2003 Interim Report for Ayers Pond Barrington

NHDES Water Division Watershed Management Bureau 29 Hazen Drive Concord, NH 03301

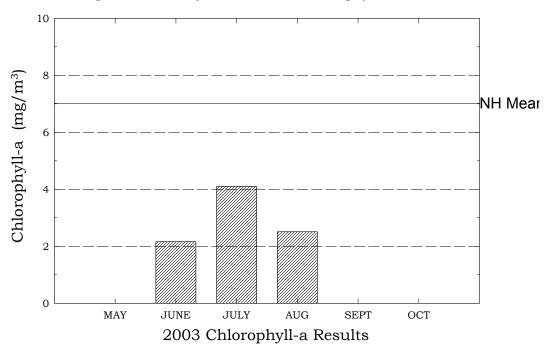
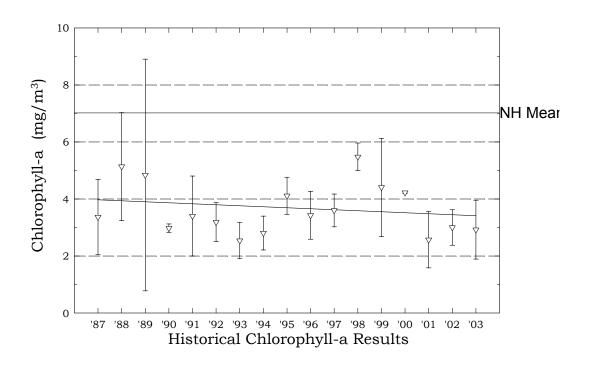
Figure 1. Monthly and Historical Chlorophyll-a Results

Figure 1 and Table 1: The graphs in Figure 1 (Appendix A) show the historical and current year chlorophyll-a concentration in the water column. Table 1 (Appendix B) lists the maximum, minimum, and mean concentration for each sampling season that the pond has been monitored through the program.

The current year data (the top graph) show that the chlorophyll-a concentration *increased* from June to July, and then *decreased* from July to August. The chlorophyll-a concentration on each sampling event was *less than* the state mean.

The historical data (the bottom graph) show that the 2003 chlorophyll-a mean is *much less than* the state mean.

Overall, visual inspection of the historical data trend line (the bottom graph) shows *a relatively stable* in-lake chlorophyll-a trend,

meaning that the concentration has **remained approximately the same** since monitoring began in 1987. In the 2004 annual report, we will conduct a statistical analysis of the historic data to objectively determine if there has been a significant change in the annual mean chlorophyll-a concentration since monitoring began.

While algae are naturally present in all lakes/ponds, an excessive or increasing amount of any type is not welcomed. In freshwater lakes/ponds, phosphorus is the nutrient that algae depend upon for growth. Algal concentrations may increase with an increase in nonpoint sources of phosphorus loading from the watershed, or inlake sources of phosphorus loading (such as phosphorus releases from the sediments). Therefore, it is extremely important for volunteer monitors to continually educate residents about how activities within the watershed can affect phosphorus loading and pond quality.

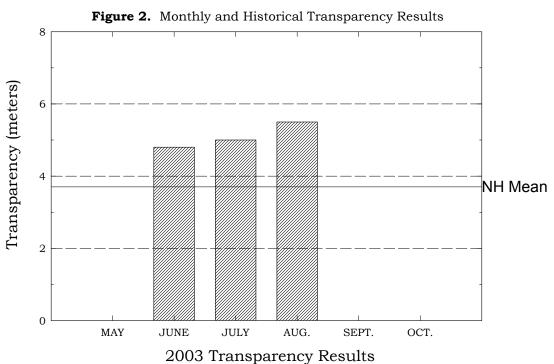
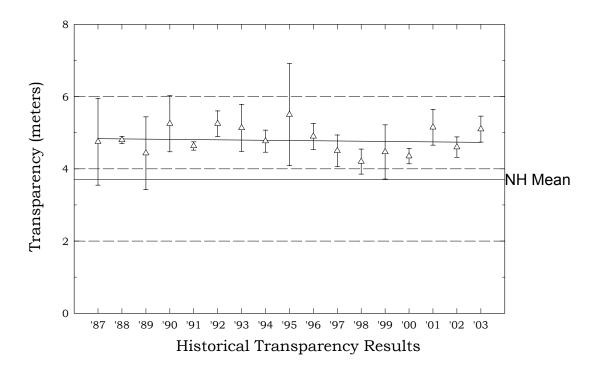
Figure 2 and Table 3: The graphs in Figure 2 (Appendix A) show historical and current year data for pond transparency. Table 3 (Appendix B) lists the maximum, minimum and mean transparency data for each sampling season that the pond has been monitored through the program.

The current year data (the top graph) show that the in-lake transparency *increased slightly* from June to August. The transparency on each sampling event was *greater than* the state mean.

Overall, visual inspection of the historical data trend line (the bottom graph) shows **a relatively stable** trend for in-lake transparency, meaning that the transparency has **remained approximately the same** since monitoring began. As discussed previously, in the 2004 annual report, we will conduct a statistical analysis of the historic data to objectively determine if there has been a significant change in the annual mean transparency since monitoring began.

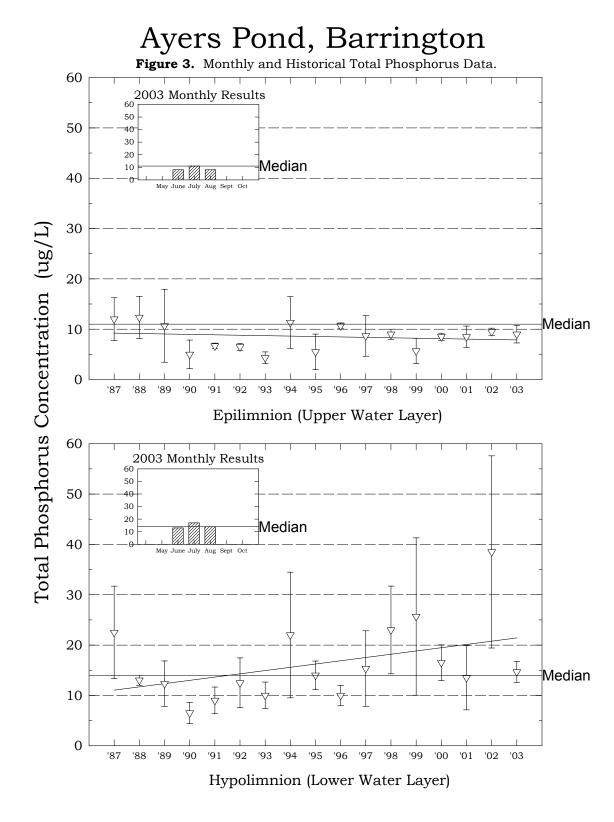
Figure 3 and Table 8: The graphs in Figure 3 (Appendix A) show the amounts of phosphorus in the epilimnion (the upper layer) and the hypolimnion (the lower layer); the inset graphs show current year data. Table 8 (Appendix B) lists the annual maximum, minimum, and median concentration for each deep spot layer and each tributary since the pond has joined the program.

The current year data for the epilimnion (the top inset graph) and the hypolimnion (the bottom inset graph) show that the phosphorus concentration *increased slightly* from June to July, and then *decreased slightly* from July to August.

The historical data show that the 2003 mean epilimnetic and hypolimnetic phosphorus concentration is **approximately equal to** the state median.

Overall, visual inspection of the historical data trend line for the epilimnion shows **relatively stable** phosphorus trend, which means that the concentration has **remained approximately the same** since monitoring began in **1987**.

Overall, visual inspection of the historical data trend line for the hypolimnion shows *a variable* phosphorus trend, which means that the concentration has *fluctuated* since monitoring began in **1987**.

One of the most important approaches to reducing phosphorus loading to a waterbody is to continually educate watershed residents about its sources and how excessive amounts can adversely impact the ecology and value of lakes and ponds. Phosphorus sources within a lake or pond's watershed typically include septic systems, animal waste, lawn fertilizer, road and construction erosion, and natural wetlands.
